Georgian House, London, W1K 7BY

Chimney Survey Report.

Chimney Survey Report

Date: 31-09-2017.

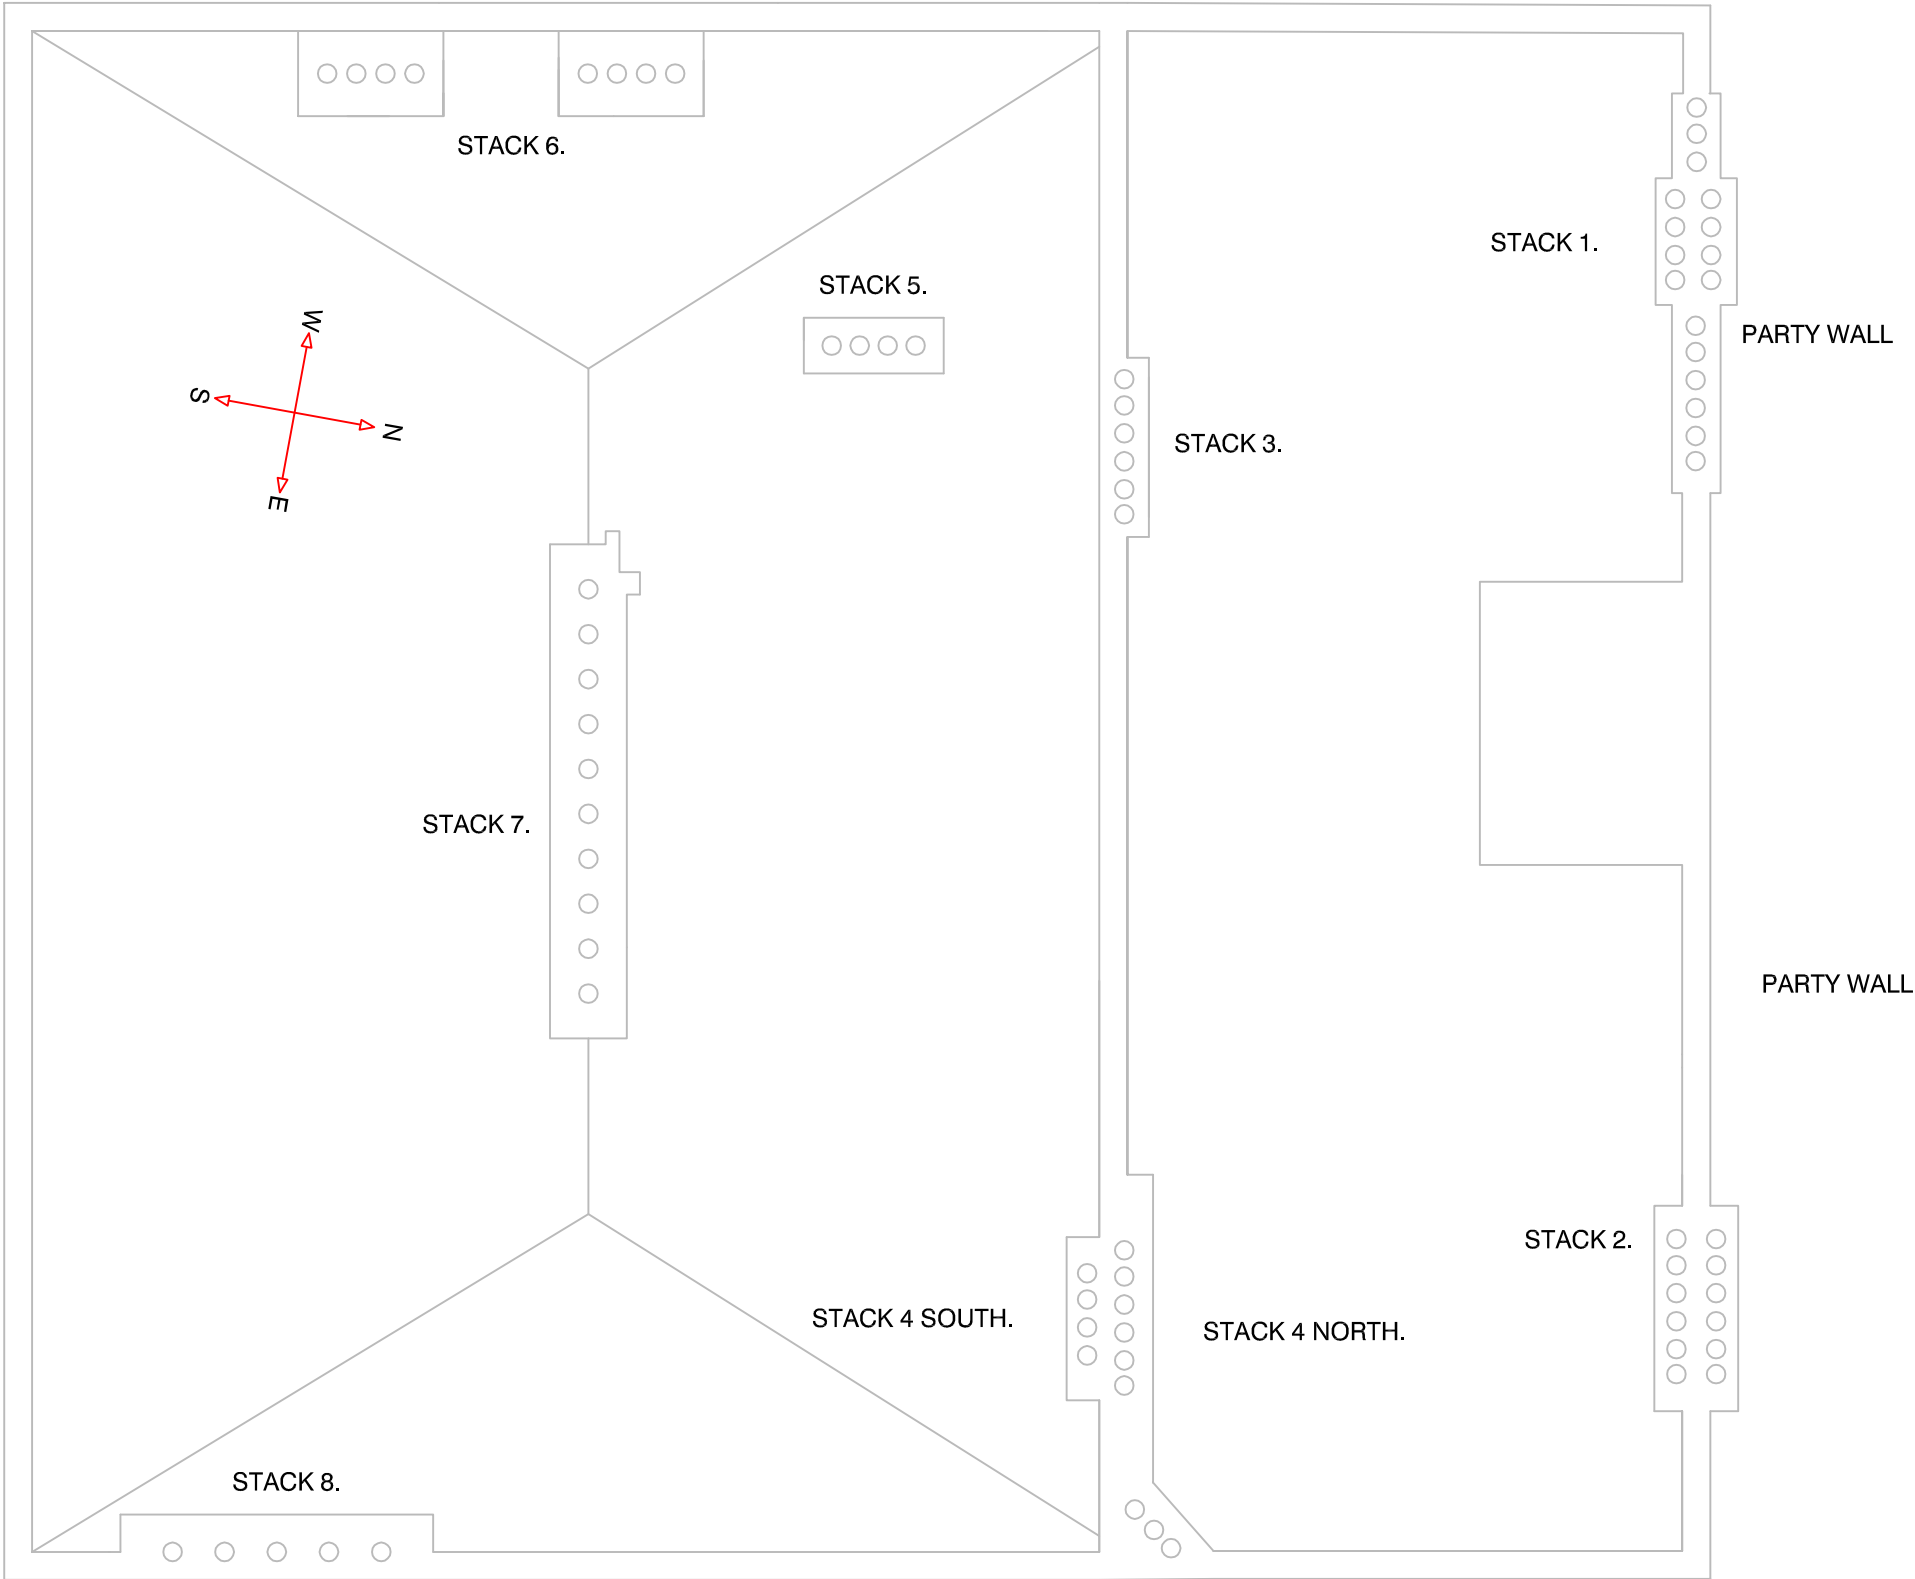
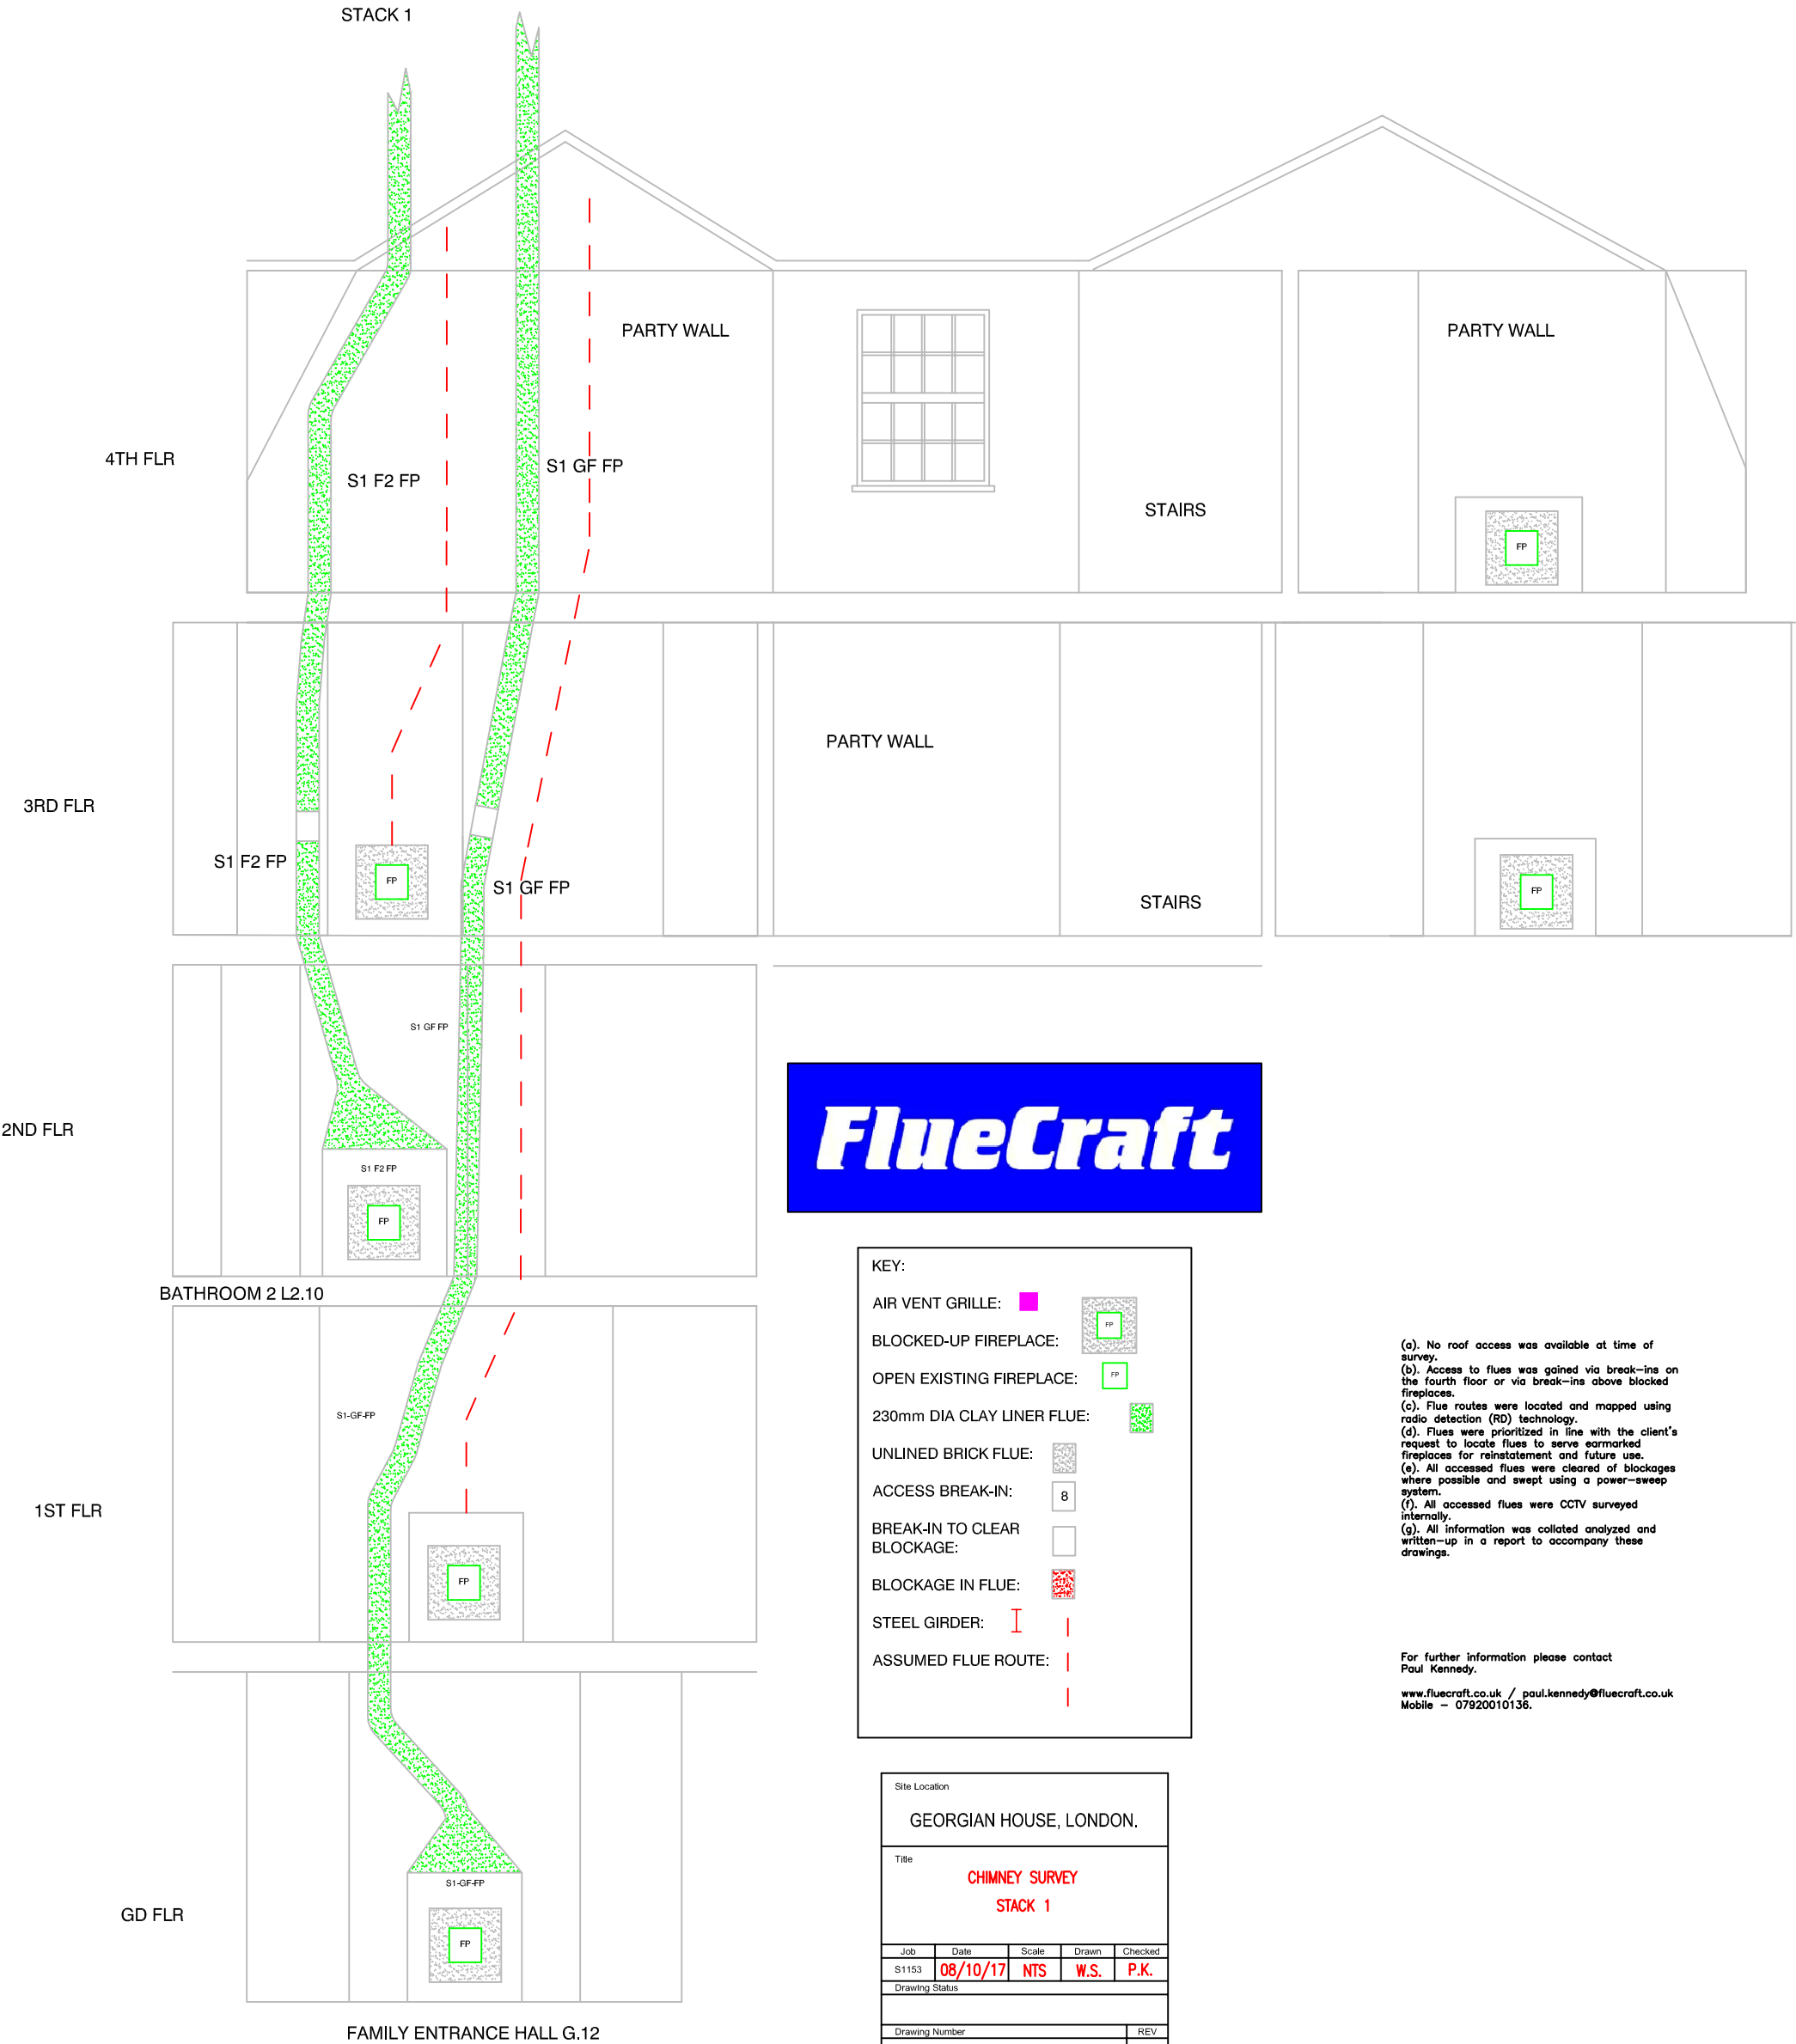
Site Location				
GEORGIAN HOUSE, LONDON.				
Title				
CHIMNEY SURVEY STACK 1				
Job	Date	Scale	Drawn	Checked
S1153	08/10/17	NTS	W.S.	P.K.
Drawing Status				
Drawing Number				
GSQ-01230617-001				REV
				C00

Stack 1 contains multiple clay flue liners. We could not drill pilot holes to locate the flue voids at high level because this stack is sitting on a party wall and there was a risk of damage to flues belonging to next door's demise. Our method was to run a radio detection device upwards from fireplace openings or break-ins just above fire place positions within the building. In this way we were able to trace the relevant flue routes upwards through the building. (See drawing GSQ-01230617-001).

S1 Ground Floor Fireplace (S1-GF-FP): This fireplace has a 230mm internal diameter clay liner which runs unobstructed up to termination point. **This flue is one of the fireplaces highlighted for re-use on the supplied brief drawings.** FAMILY ENTRANCE HALL G.12.

S1 Second Floor Fireplace (S1-F2-FP): This fireplace has a 230mm internal diameter clay liner which runs unobstructed up to termination point. **This flue is one of the fireplaces highlighted for re-use on the supplied brief drawings.** BATHROOM 2 L2.10.

S1 Break-in No. S1-GF-FP. CCTV footage shows that the clay liner is in relatively fair condition but with some poor joints. This runs down to the ground floor to an existing blocked fireplace opening. **This flue is one of the fireplaces highlighted for re-use on the supplied brief drawings.** G.12.

S1 Break-in No. S1-F2-FP. CCTV footage shows that the clay liner is in relatively fair condition but with some poor joints. This runs down to the second floor to an existing blocked fireplace opening. **This flue is one of the fireplaces highlighted for re-use on the supplied brief drawings.** L2.10.

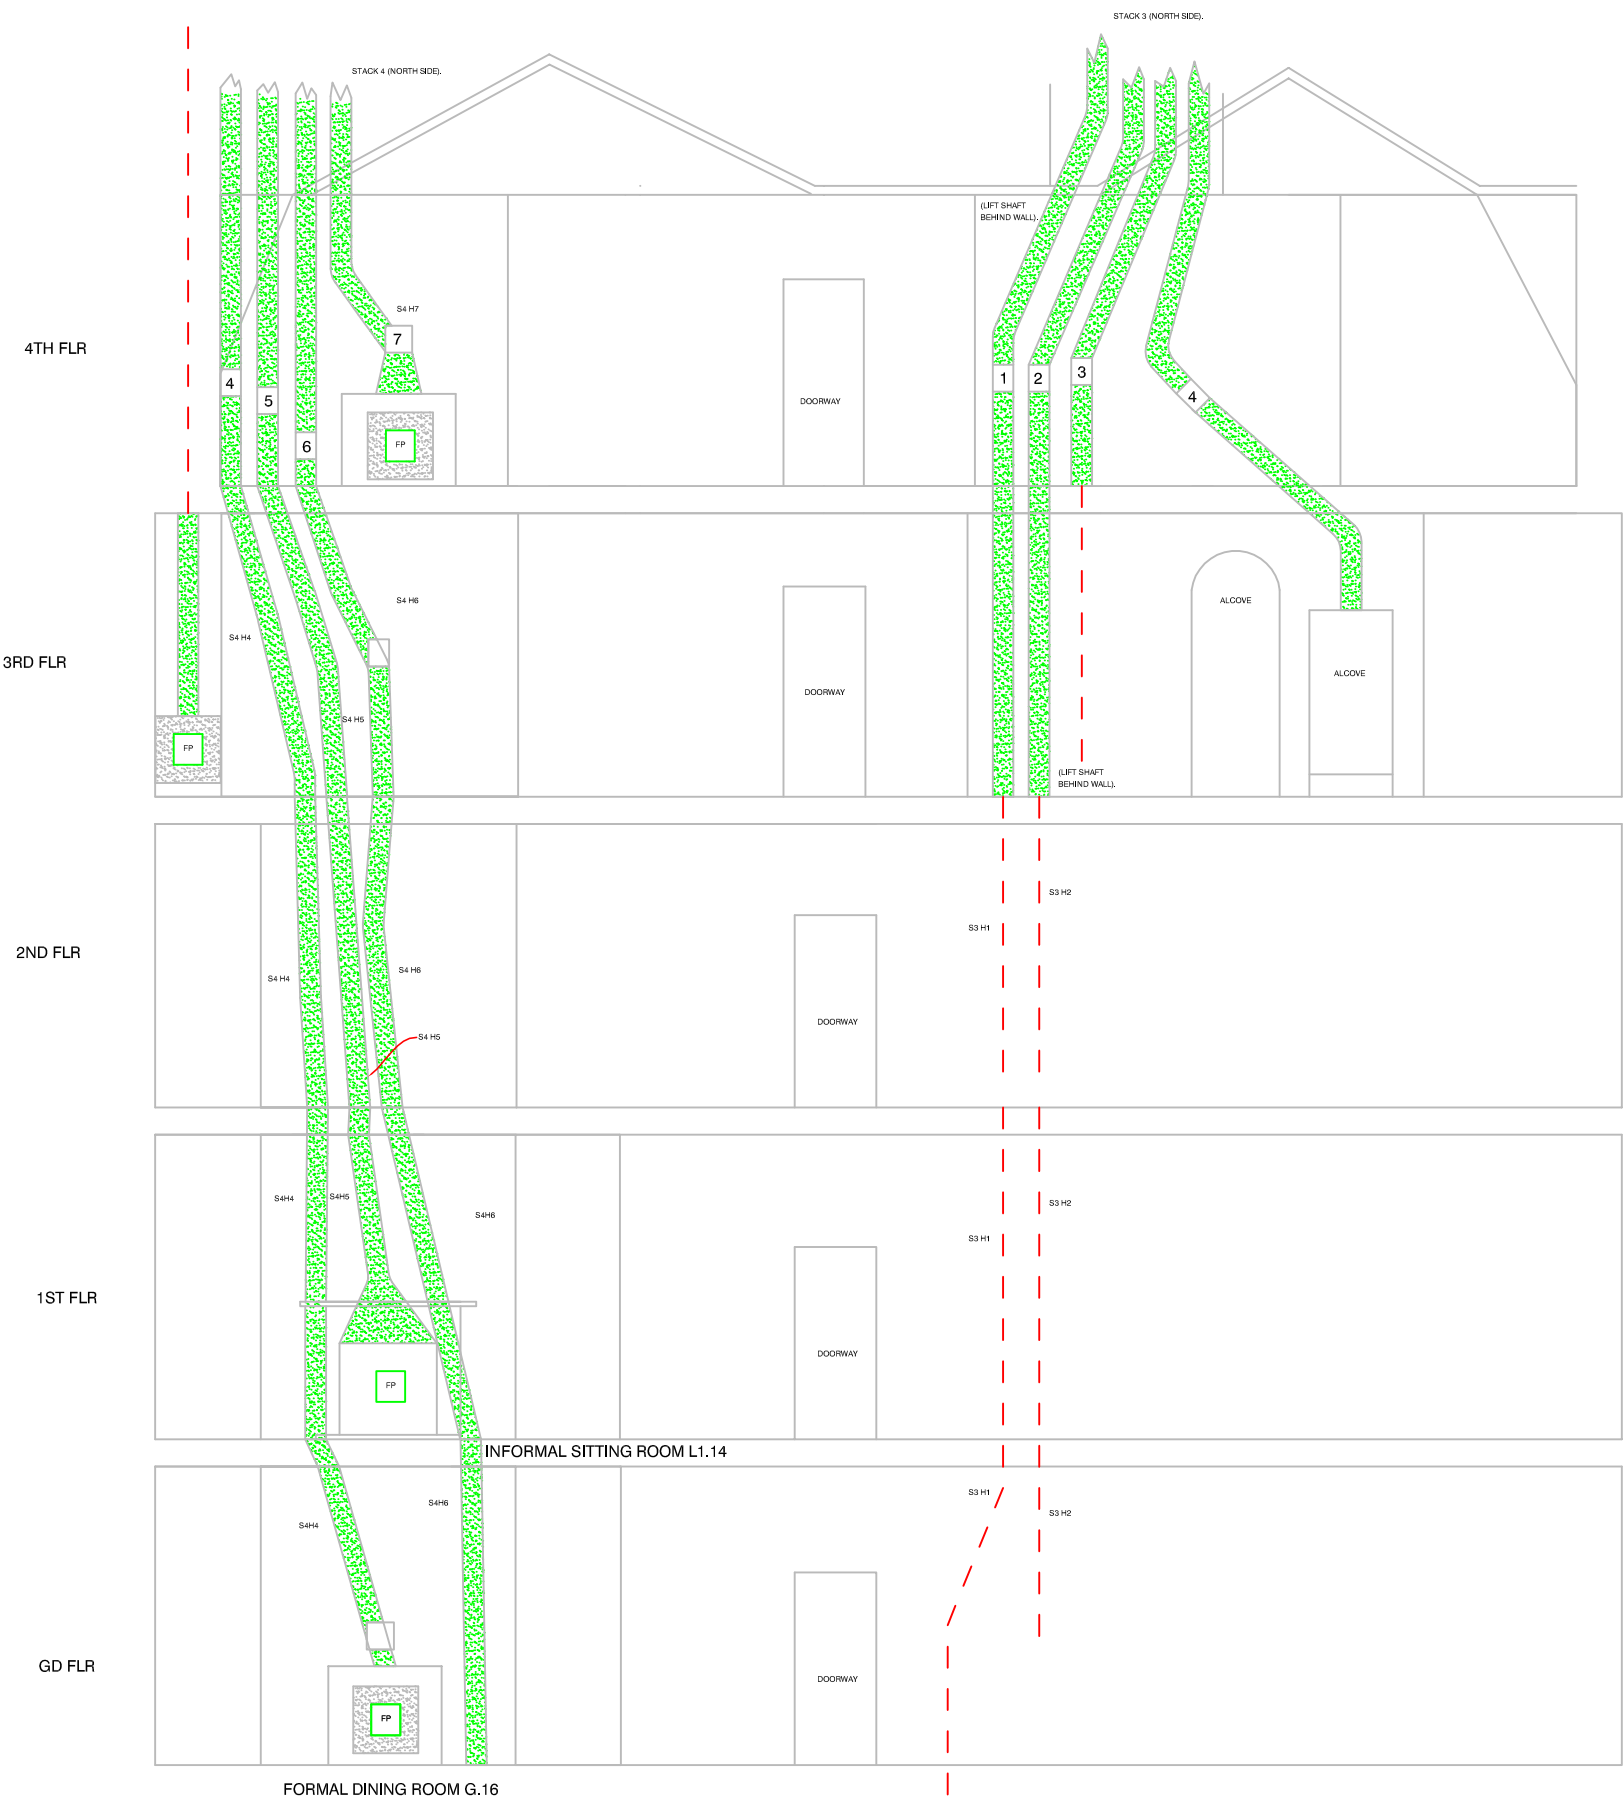
Site Location	
GEORGIAN HOUSE, LONDON.	
Title	
CHIMNEY SURVEY STACKS 4 & 3 NORTH	
Job	Date
S1153	08/10/17
Scale	NTS
Drawn	W.S.
Checked	P.K.
Drawing Status	
Drawing Number	
GSQ-01230617-004N-003N	
REV	
C00

S4 Break-in No. 4 (north side). This contains a 230mm internal diameter clay liner which runs unobstructed down to a defunct fireplace recess on the ground floor. This flue is one of the fireplaces highlighted for re-use on the supplied brief drawings. FORMAL DINING ROOM G.16.

S4 Break-in No. 5 (north side). This contains a 230mm internal diameter clay liner which runs down unobstructed to an existing fireplace on the first floor. This flue is one of the fireplaces highlighted for re-use on the supplied brief drawings. FORMAL SITTING ROOM L1.14.

S4 Break-in No. 6 (north side). This contains a 230mm internal diameter clay liner which runs unobstructed down to the basement and passes the ground floor fireplace on the right-hand side. This flue is not one of the fireplaces highlighted for re-use on the supplied brief drawings.

S4 Break-in No. 4 (north side). CCTV footage shows that the clay liner is in relatively fair condition but with some poor joints. This runs down to a bricked-in fireplace position on the ground floor. This flue should be re-lined with Furanflex liner if the fireplace is to be brought back into use as an open gas fire. **This flue is one of the fireplaces highlighted for re-use on the supplied brief drawings.** G.16.

S4 Break-in No. 5 (north side). CCTV footage shows that the clay liner is in relatively fair condition but with some poor joints. This runs down to an open fireplace position on the first floor. This flue should be re-lined with Furanflex liner if the fireplace is to be brought back into use as an open gas fire. **This flue is one of the fireplaces highlighted for re-use on the supplied brief drawings.** L1.14.

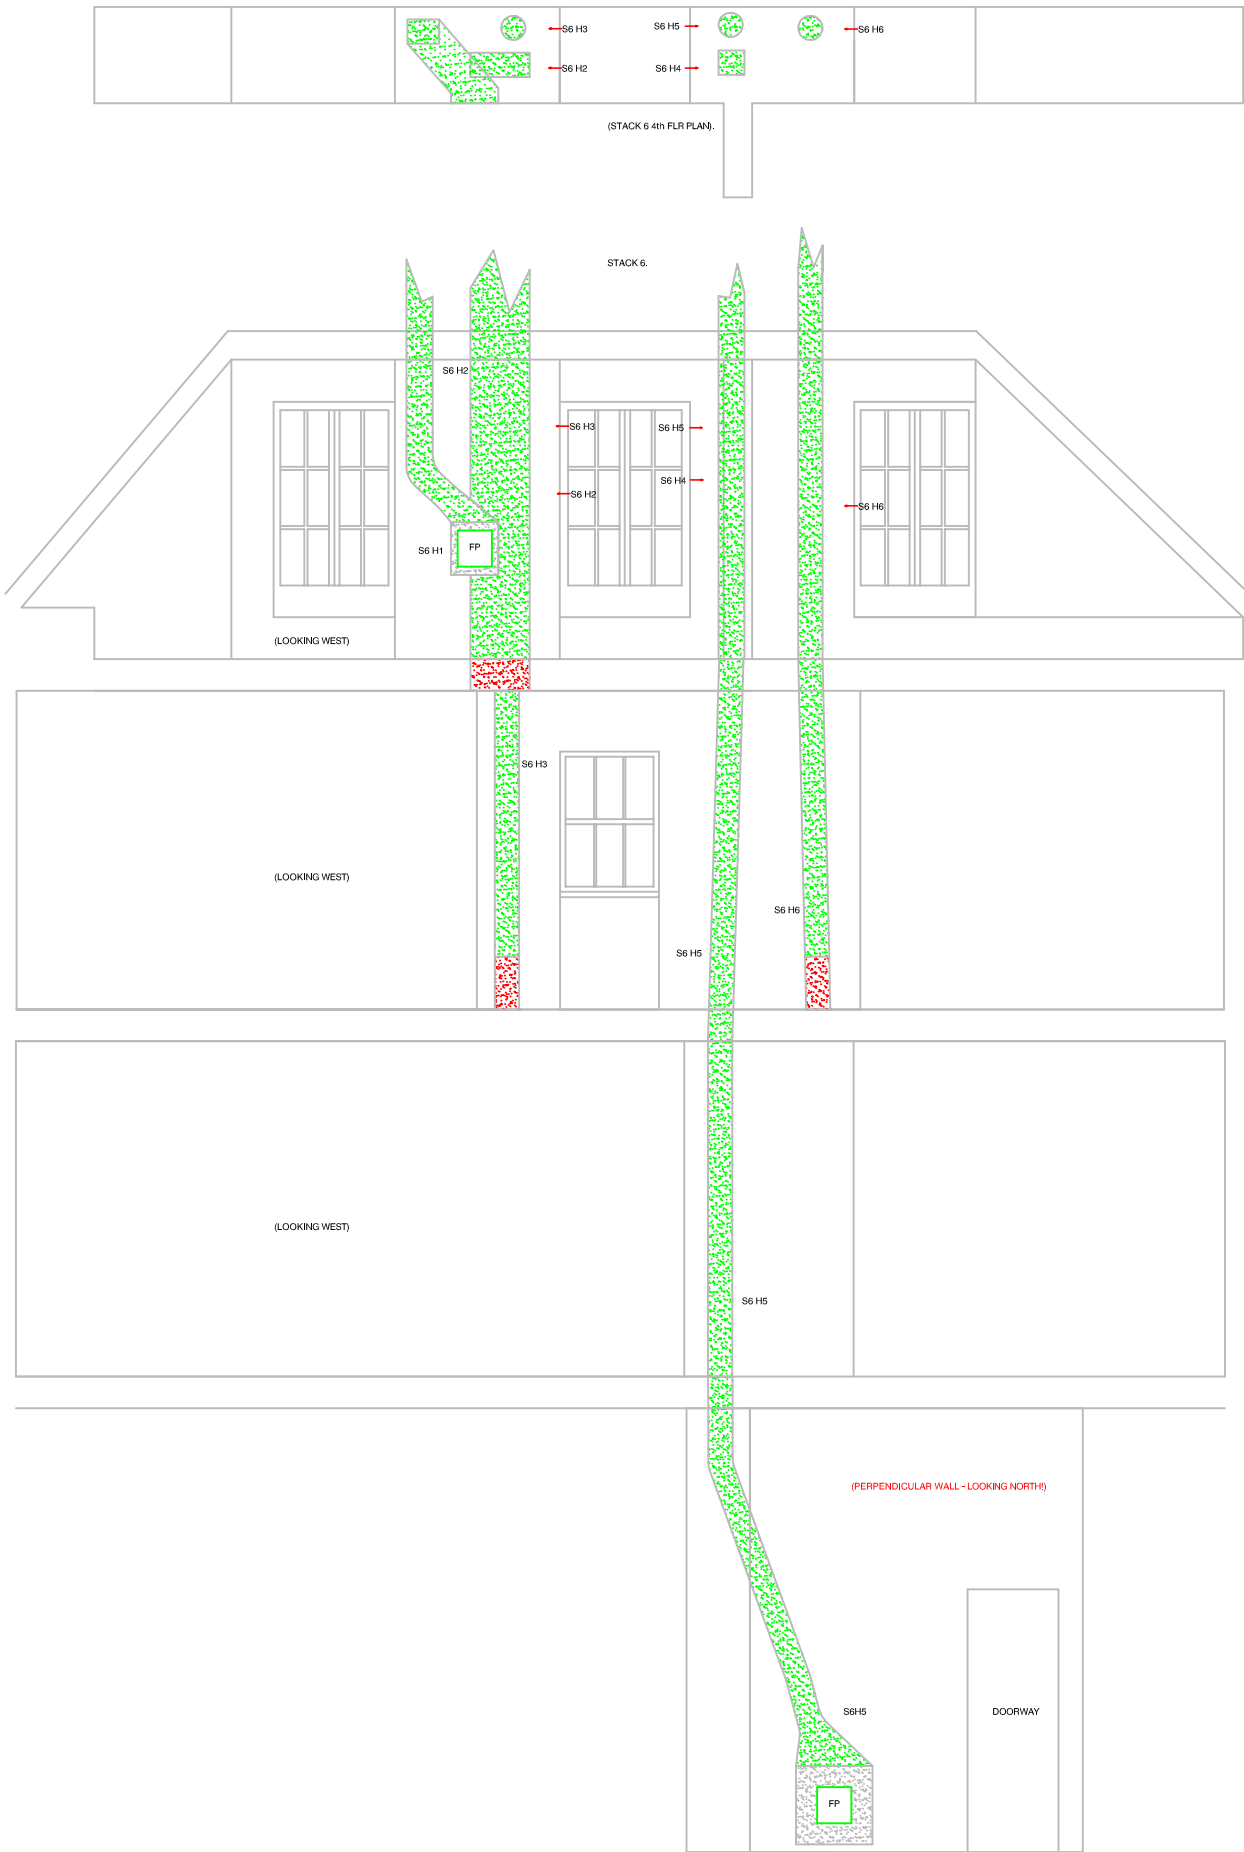
Site Location				
GEORGIAN HOUSE, LONDON.				
Title				
CHIMNEY SURVEY STACK 6				
Job	Date	Scale	Drawn	Checked
S1153	08/10/17	NTS	W.S.	P.K.
Drawing Status				
Drawing Number				REV
GSQ-01230617-006				C00

S6 Break-in No. 1 has an unlined flue-way which serves a small bricked-up fireplace on the fourth floor. This flue dives back towards Dunraven St. as it ascends upwards, making it unlikely that there could be room for another flue behind it as indicated by the supplied briefing drawing showing the configuration of chimney pots on the stack. **This flue is not one of the fireplaces highlighted for re-use on the supplied brief drawings.**

S6 Break-in No. 2 contains an unlined rectangular brick flue which is blocked / scrubbed at floor level on the fourth floor. **This flue is not one of the fireplaces highlighted for re-use on the supplied brief drawings.**

S6 Break-in No. 3 contains a 230mm internal diameter clay liner which runs down to floor level on the third floor where it is scrubbed. **This flue is not one of the fireplaces highlighted for re-use on the supplied brief drawings.**

S6 Break-in No. 4 contains an unlined brick flue-way which is scrubbed at fourth floor level. **This flue is not one of the fireplaces highlighted for re-use on the supplied brief drawings.**

S6 Break-in No. 3 CCTV footage shows that the clay liner is in poor condition with multiple breaks and some poor joints. Full blockage at third floor. **This flue is not one of the fireplaces highlighted for re-use on the supplied brief drawings.**

S6 Break-in No. 5 CCTV footage shows that the clay liner is in poor condition with multiple breaks and some poor joints. Bricked-in fireplace at first floor. If this flue is to be re-used as a possible gas fireplace flue it should be re-lined with Furanflex liner.

S6 Break-in No. 6 CCTV footage shows that the clay liner is in poor condition with multiple breaks and some poor joints. Full blockage at third floor. This flue is not one of the fireplaces highlighted for re-use on the supplied brief drawings.

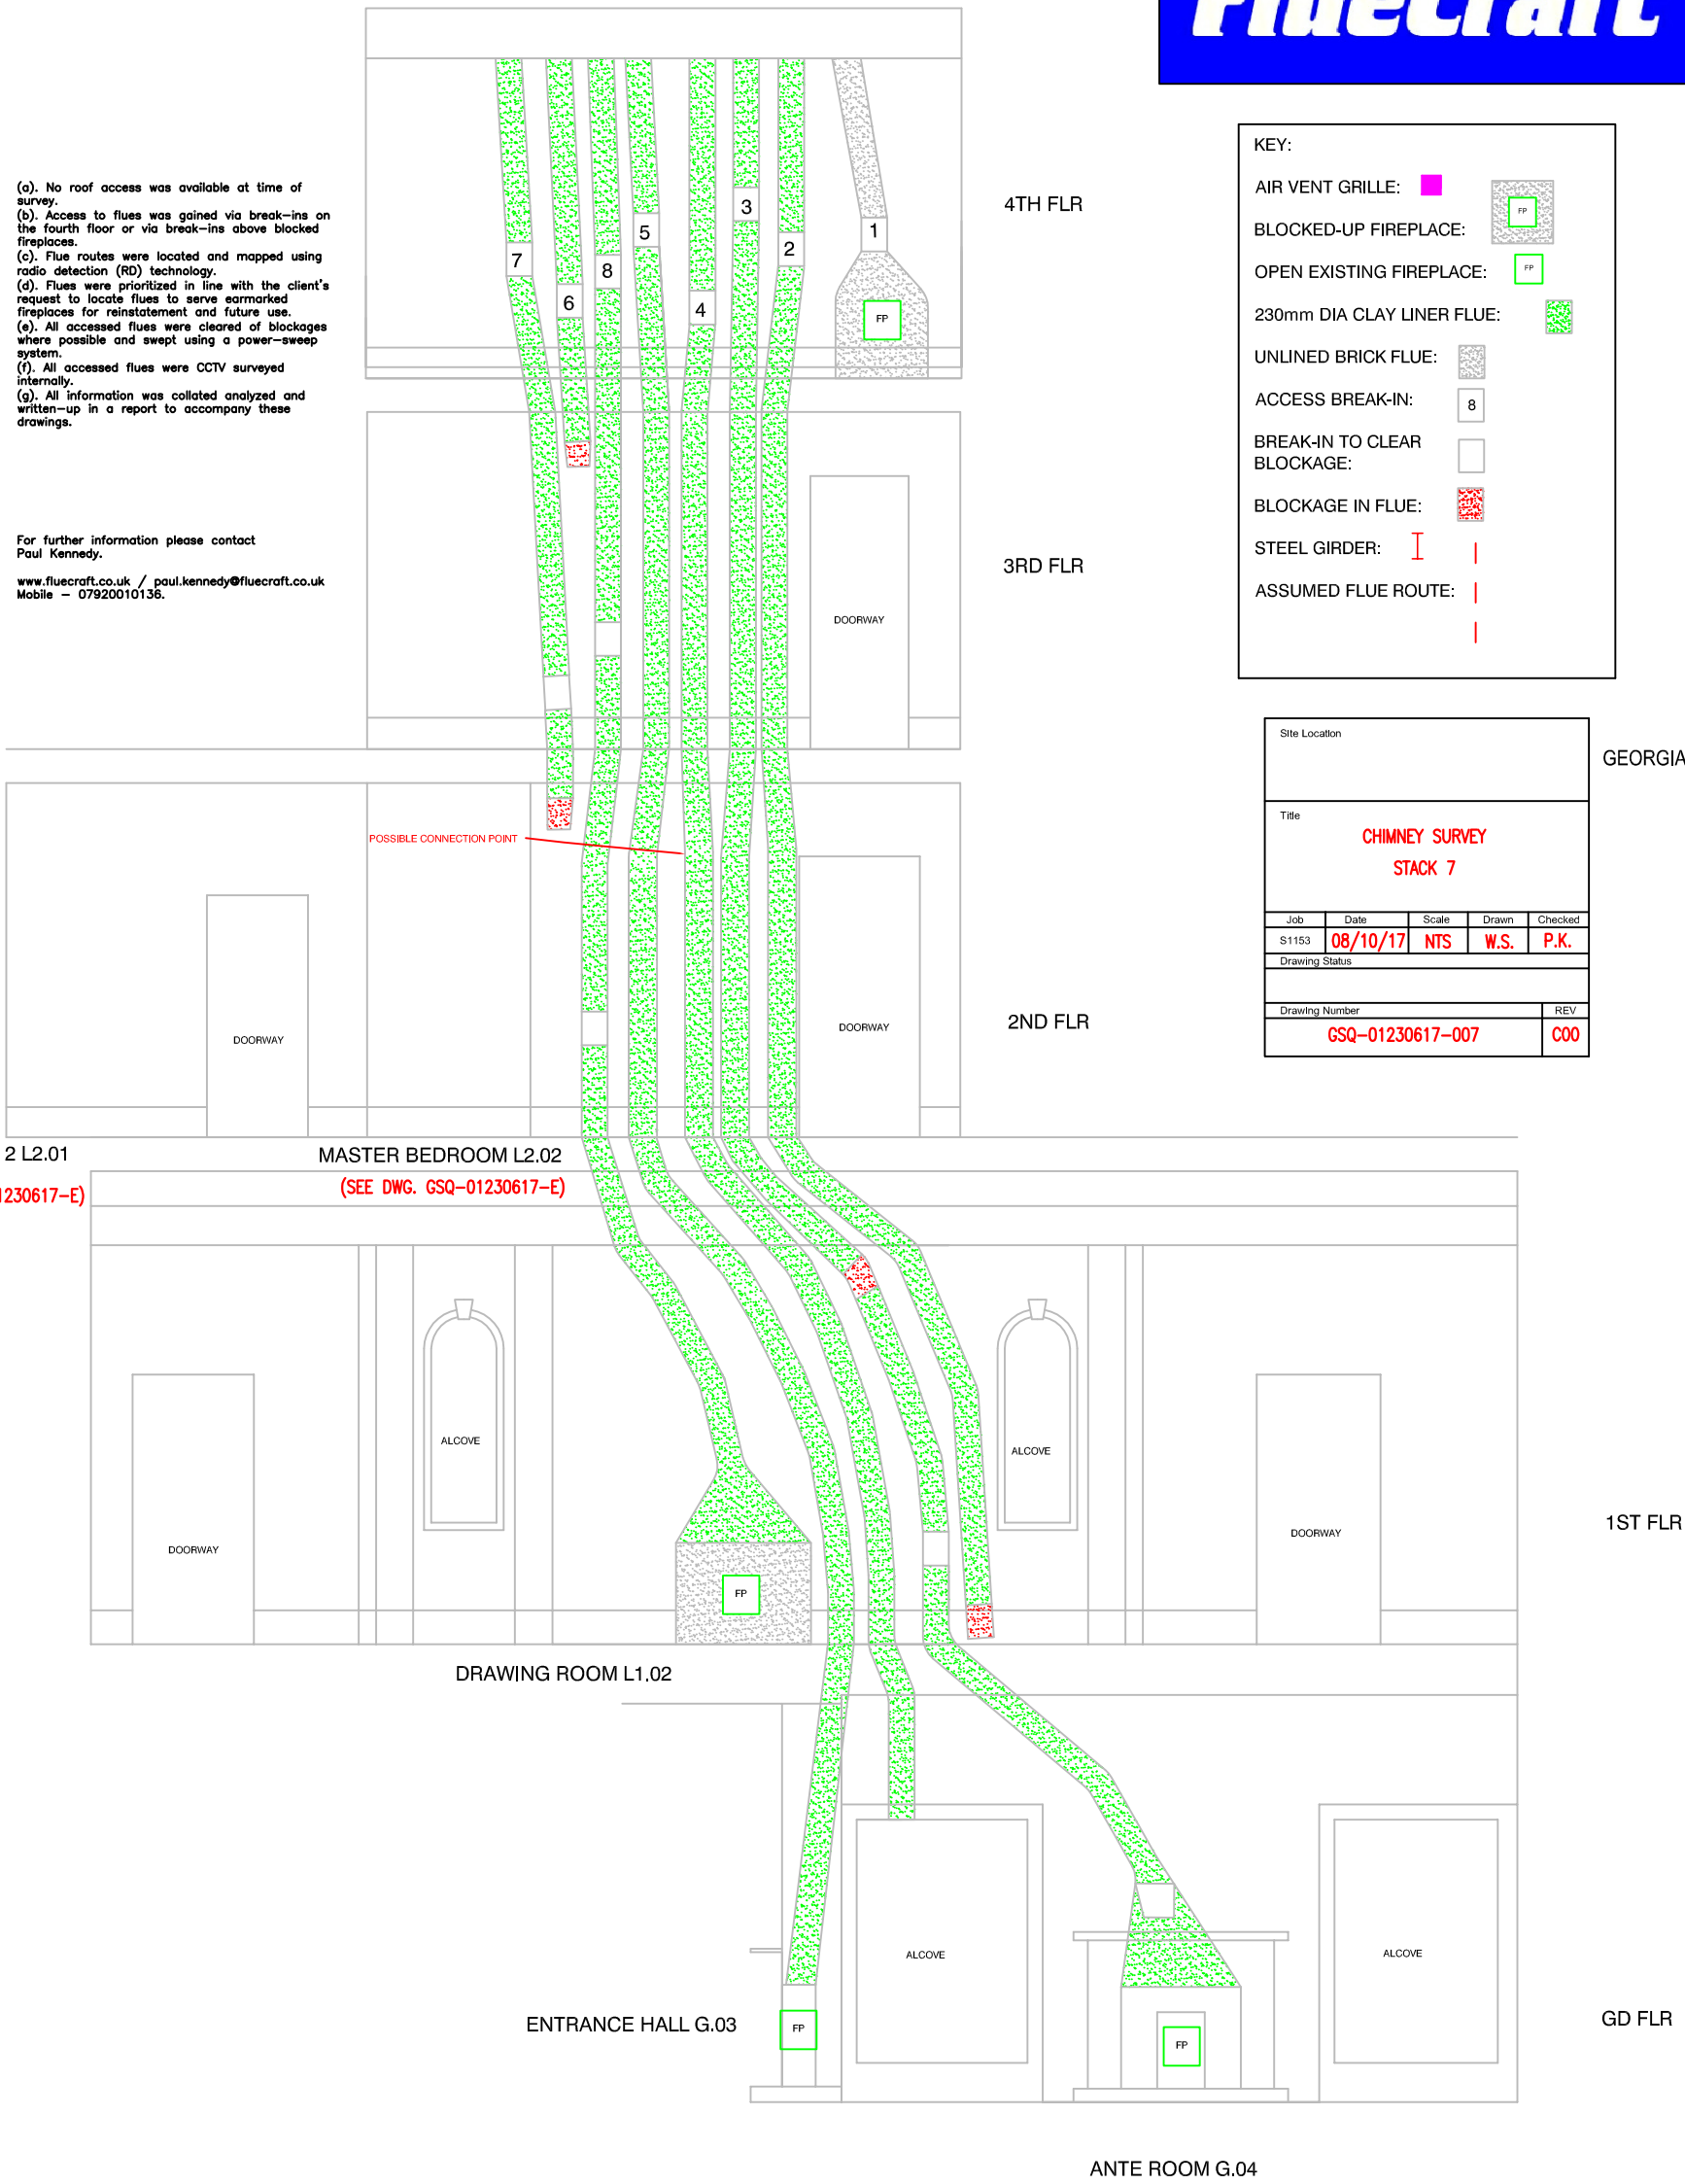
Site Location				
GEORGIAN HOUSE, LONDON.				
Title				
CHIMNEY SURVEY STACK 7				
Job	Date	Scale	Drawn	Checked
S1153	08/10/17	NTS	W.S.	P.K.
Drawing Status				
Drawing Number				REV
GSQ-01230617-007				C00

S7 Break-in No. 2 CCTV footage shows that the clay liner is in good condition but with some poor joints. The flue route runs down to floor level on the first floor where there is a full blockage. This flue is not one of the fireplaces highlighted for re-use on the supplied brief drawings.

S7 Break-in No. 3 CCTV footage shows that the clay liner is in good condition but with some poor joints. The flue route runs down to a blockage at ceiling level on the first floor. Below this blockage the liner runs down to an open fireplace on the ground floor front of house, (room on the right of entrance hall). This flue should be re-lined with Furanflex liner if the fireplace is to be brought back into use as an open gas fire. This flue is not one of the fireplaces highlighted for re-use on the supplied brief drawings. It may be used to reinstate fireplace ANTE ROOM G.04 however.

S7 Break-in No. 4 CCTV footage shows that the clay liner is in good condition but with some poor joints. The flue route runs down to a blockage above an alcove on the ground floor front of house, (room on the right of entrance hall). **This flue is not one of the fireplaces highlighted for re-use on the supplied brief drawings. This flue could be used to provide a route for the proposed new fireplace in the MASTER BEDROOM SUITE L2.02.** (see drawing GSQ-01230617-E).

S7 Break-in No. 5 CCTV footage shows that the clay liner is in good condition but with some poor joints. The flue route runs down to the open fireplace on the righthand side of the entrance hall. This flue should be re-lined with Furanflex liner if the fireplace is to be brought back into use as an open gas fire. **This flue is one of the fireplaces highlighted for re-use on the supplied brief drawings.** G.03.

S7 Break-in No. 6 CCTV footage shows that the clay liner is in good condition but with some poor joints. The flue route runs down to a full blockage at ceiling height on the third floor. **This flue is not one of the fireplaces highlighted for re-use on the supplied brief drawings.**

S7 Break-in No. 7 CCTV footage shows that the clay liner is in good condition but with some poor joints. The flue route runs down to a full blockage at ceiling height on the second floor. **This flue is not one of the fireplaces highlighted for re-use on the supplied brief drawings.**

S7 Break-in No. 8 CCTV footage shows that the clay liner is in good condition but with some poor joints. The flue route runs down to a bricked-in fireplace on the first floor. This flue should be re-lined with Furanflex liner if the fireplace is to be brought back into use as an open gas fire. **This flue is one of the fireplaces highlighted for re-use on the supplied brief drawings.** L1.02.

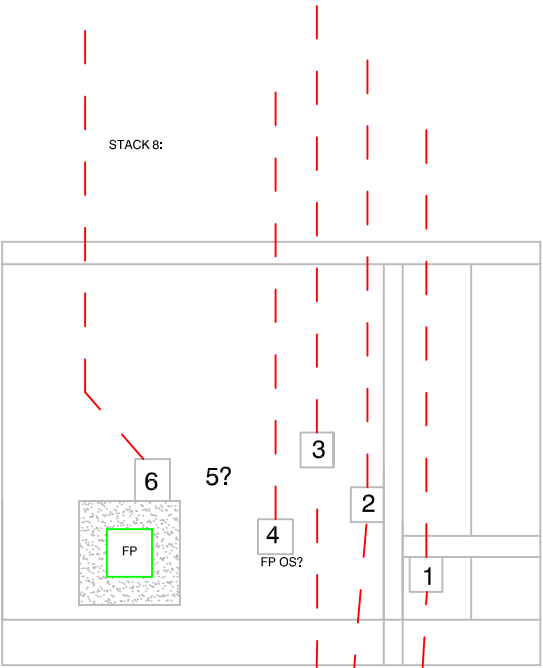
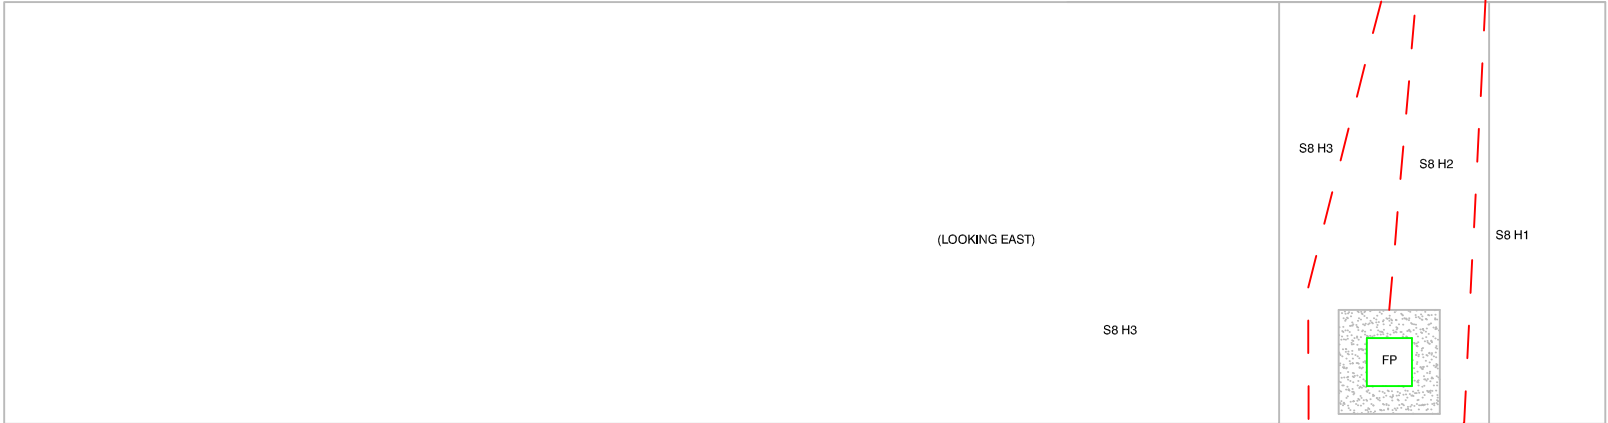
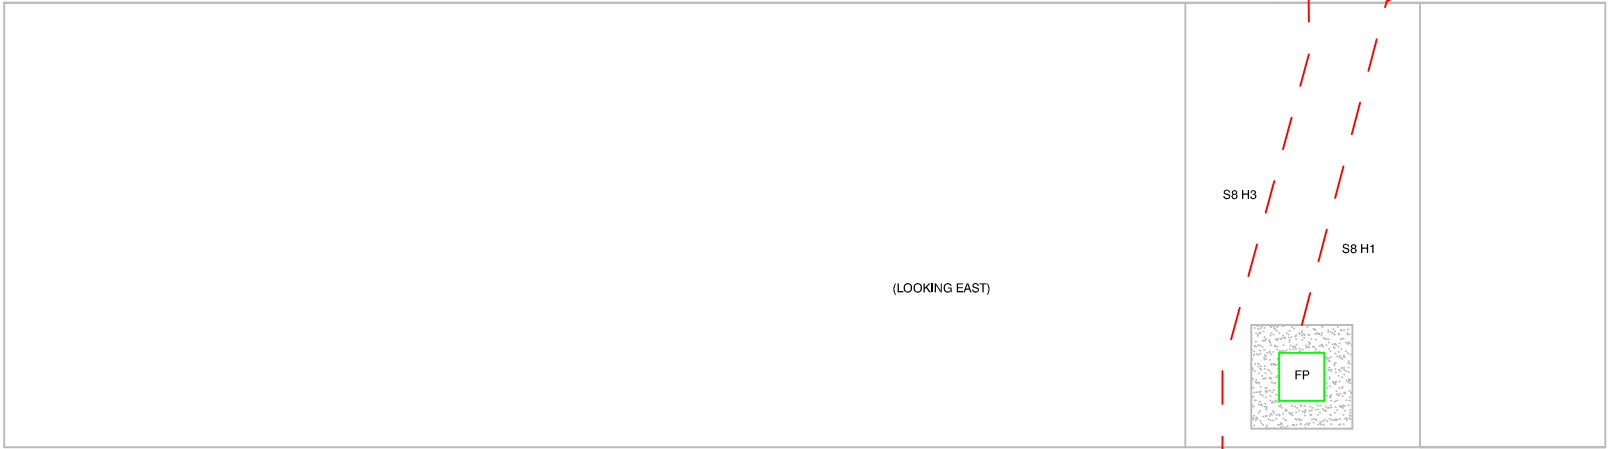
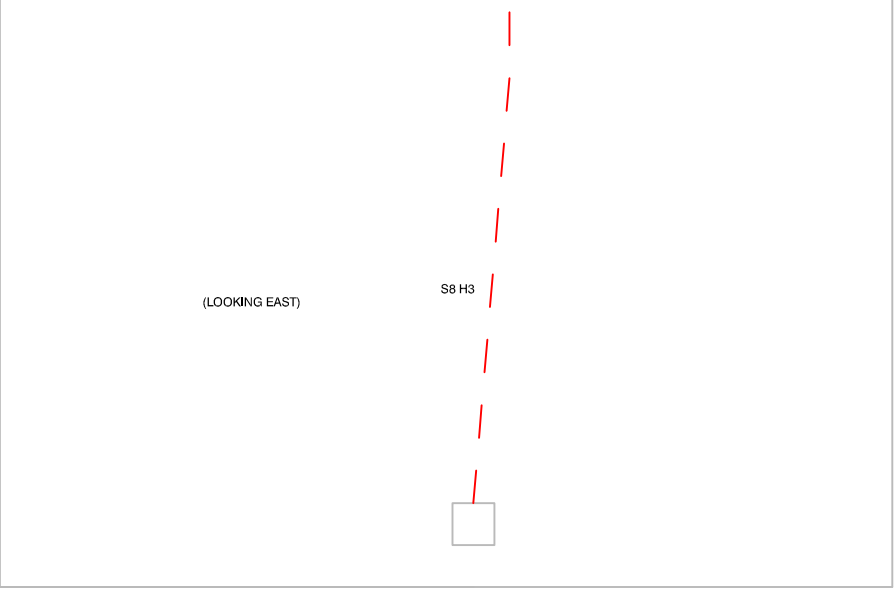
Site Location				
GEORGIAN HOUSE, LONDON.				
Title				
CHIMNEY SURVEY				
STACK 8				
Job	Date	Scale	Drawn	Checked
S1153	08/10/17	NTS	W.S.	P.K.
Drawing Status				
Drawing Number				REV
GSQ-01230617-008				C00

*NB: STACK 8 WAS NOT A PRIORITY STACK FOR FULL INVESTIGATION. THE ROUTES SHOWN ARE SPECULATIVE ONLY. (IF REQUIRED THESE ROUTES CAN BE INVESTIGATED FURTHER).
